THE RECOVERY, RECONSTRUCTION, AND ANALYSIS OF YENİKAPI 14 (YK
14), A MIDDLE BYZANTINE MERCHANT SHIP FROM THE THEODOSIAN
HARBOR EXCAVATIONS AT YENİKAPI, ISTANBUL

A Dissertation

MICHAEL RICE JONES

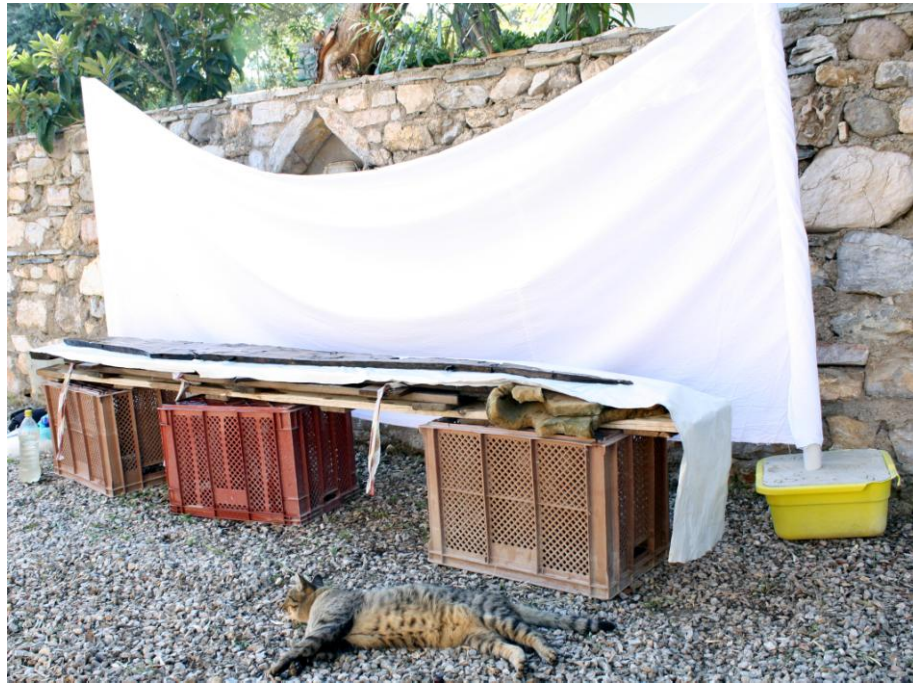
Figure 2.27: Set-up for photographing the edge of a hull plank using plastic crates, a wooden pallet, and photography backdrop constructed from linen sheets, PVC pipes, and a pair of concrete-and-reinforcement-bar bases.

A four-meter-long white linen sheet attached to a pair of PVC pipes was also used as a photographic backdrop, particularly for larger timbers; two lengths of reinforcement bar embedded in concrete bases were used to support the backdrop when necessary (**Figure 2.27**).²³⁹ Timbers were kept wet while photographing, although it was found that the best results for photographing surface features were when the surfaces were only slightly wet: this greatly enhanced the visibility of surface details such as tool marks, but without the reflections caused by excessive water or the dull appearance of a drier timber surface.

²³⁹ The photographic set-up, conceived and assembled by Rebecca Ingram, consisted of two concrete bases with lengths of rebar embedded in them. A four-meter white sheet was sewn over so that its ends formed sleeves that fitted over two-meter-long PVC pipes, which were in turn inserted on the reinforcement bars. The sheet could be rolled or unrolled to the desired length (up to four meters), depending on the length of the piece being photographed.

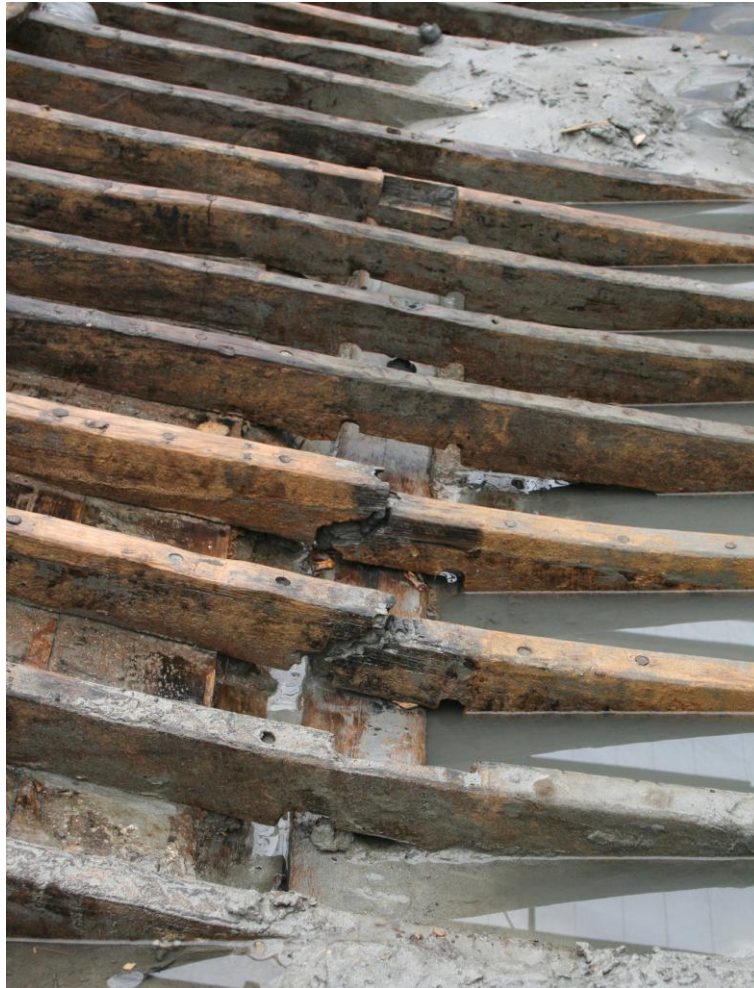
Figure 3.11: View of the keel area amidships during excavation, with FL 22 in the foreground. Note the breaks on floors FL 23-24 where they overlap the keel, and the separation of FL 25-28 from the keel.

Some distortion of the ship's hull occurred during and after the ship's sinking. Planking sprung outward from broken sections of the hull above the turn of the bilge, particularly SS 7-2 on the port side and the strakes above PS 10 on the starboard side between frames 31-46. The hull is slightly hogged, probably due to a combination of distortion that occurred during the life of the ship and compression of the hull occurring after the ship's sinking and deposition in the harbor. Most of the floor timbers in the central section of the hull had pulled away from the keel, probably during the wrecking of the ship. This resulted in cracks and breaks in several floor timbers where they overlap the keel, particularly at the locations of nails used to fasten the floors to the keel (**Figure 3.11**). The floors were separated from the keel at FL 4-5, 16-35, and, to a lesser extent FL 39-46, with those between FL 21-35, or approximately amidships, pulled furthest away

from the keel's inner face. The formation of iron concretions on the outer faces of the keel nails at FL 26, 30, and 32 preserved the approximate width of the gap between the outer face of these floor timbers and the inner face of the keel: the gap ranged from a few millimeters (FL 16-20, FL 39-46), to several centimeters along the main keel timber, Keel 2 (FL 21-35). While the main keel timber appears to have remained relatively straight, some bending or distortion is evident at both scarf ends of the timber.

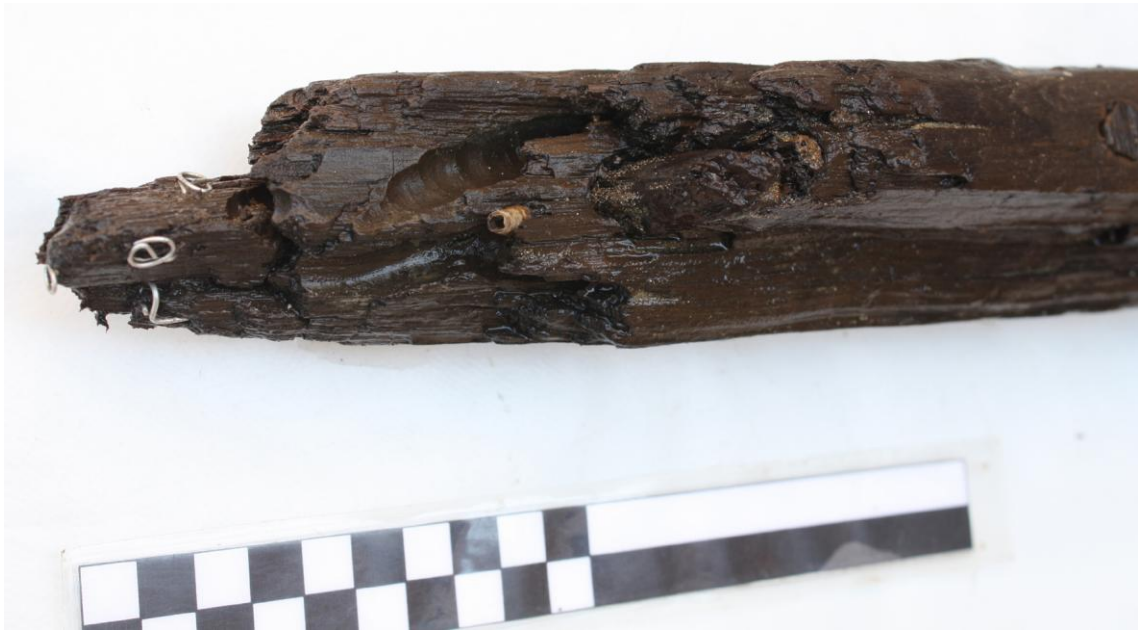
Figure 3.12: Teredo worm damage on the upper end of futtock F 17, one of the few timbers in YK 14's hull to exhibit such damage.

Post-sinking shipworm or teredo worm damage was seen on several timbers only in the uppermost section of the hull, including planks PS 9-1, PS 14-1, and SS 6-1, and in the upper ends of frames FL 7, F 11, F 13, F 17, and possibly FL 4 (**Figure 3.12**). The largest of the teredo worm holes were 0.8-1.2 cm in diameter, but most are only 0.4-0.5 cm in diameter. These holes were usually scattered in the upper extremity of the hull, and their absence elsewhere indicates a relatively short period of exposure to marine borers. Knot holes and cavities caused by boring insects and wood rot were present in several timbers. In some cases holes in the hull planks were plugged with caulking and pitch: these include a knot hole in plank SS 4-2 (**Figure 3.13**) and a boring left by beetle larvae in plank SS 5-2.²⁴⁴ A possible insect hole, which was not plugged due to its presence in the interior of the hull, was also found in floor FL 29. Wood rot, which caused some of the most serious damage in the hull, occurred before the ship's sinking on many frame and planking timbers as well.

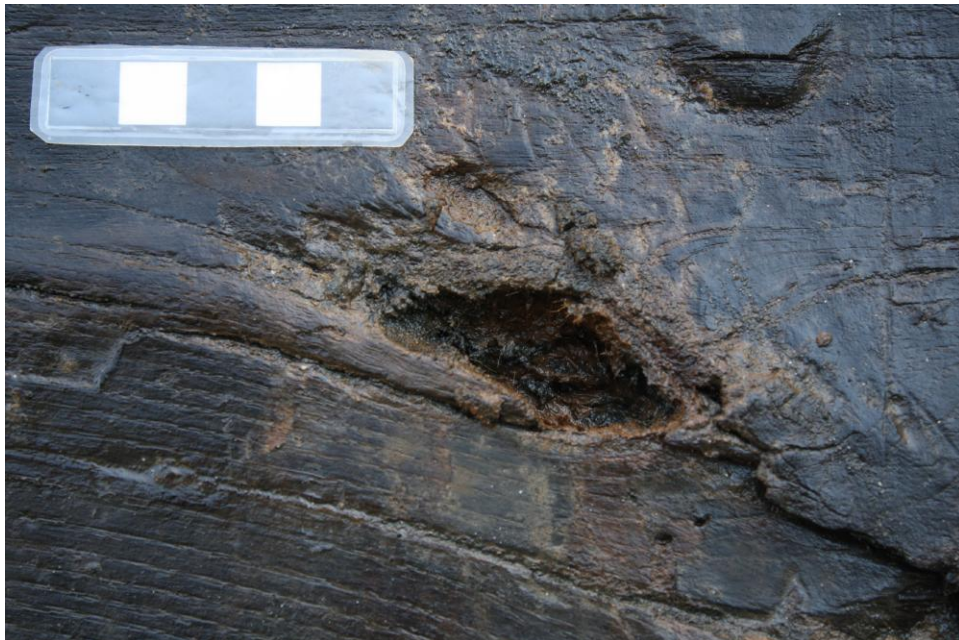
Figure 3.13: Knot hole in plank SS 4-2 repaired with a plug of pitch, hair, and grass. Note the hair in the plug, which had been partially removed when the photograph was taken.

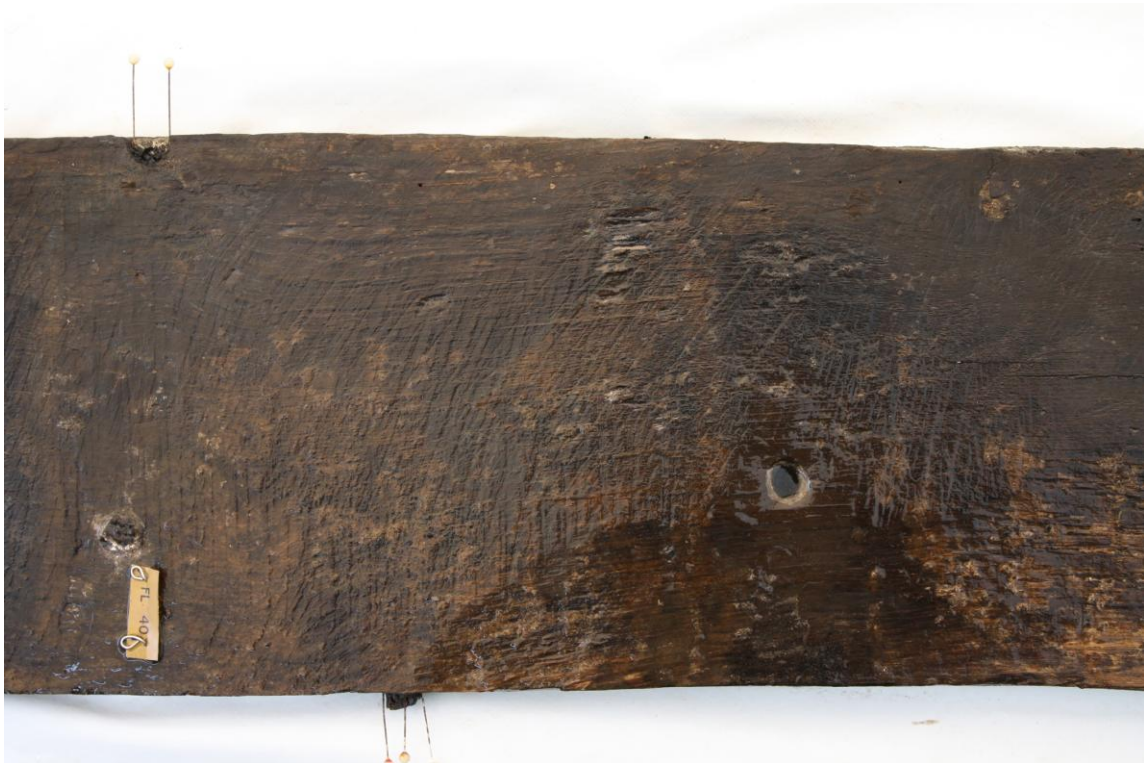
Figure 3.14: Saw marks on SS 1-3 angled in multiple directions. Note also the adzed area towards the lower edge of the plank.

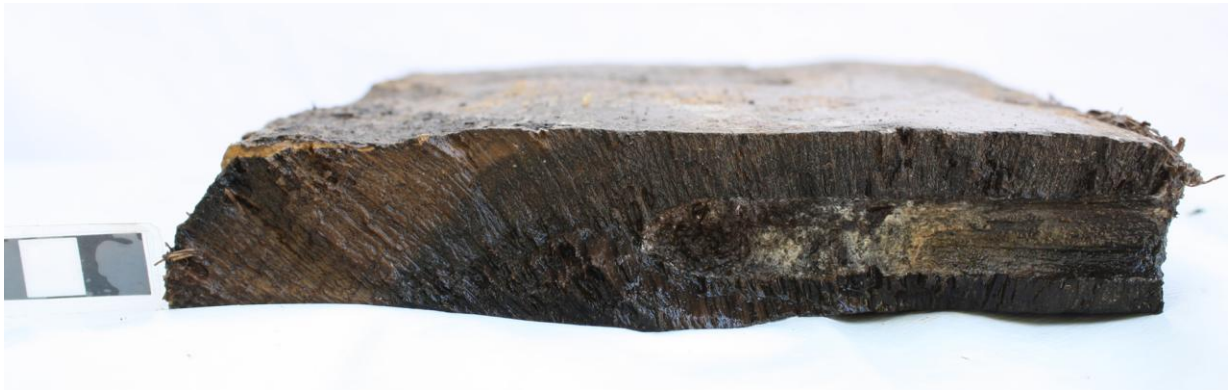
Figure 3.15: Example of clearly visible wood grain and tree rings at a break in plank PS 2-2, between frames FL 24 and 25.

A small handsaw may have been used to cut diagonal scarfs on planking, scarf ends on frames and keel timbers, and for other jobs requiring more precision. Examination of the tree rings at ends and breaks of hull planks indicate that they were plain sawn from logs of relatively small-diameters (**Figure 3.15**).²⁵¹ The use of smaller saws seem to be indicated by saw cuts on smaller-sized timbers, more closely-spaced saw marks (often only 0.1-0.5 cm apart, which was common on the sawn faces of curved sections of floor timbers), or saw marks that show more variety in orientation on a particular face of a timber.

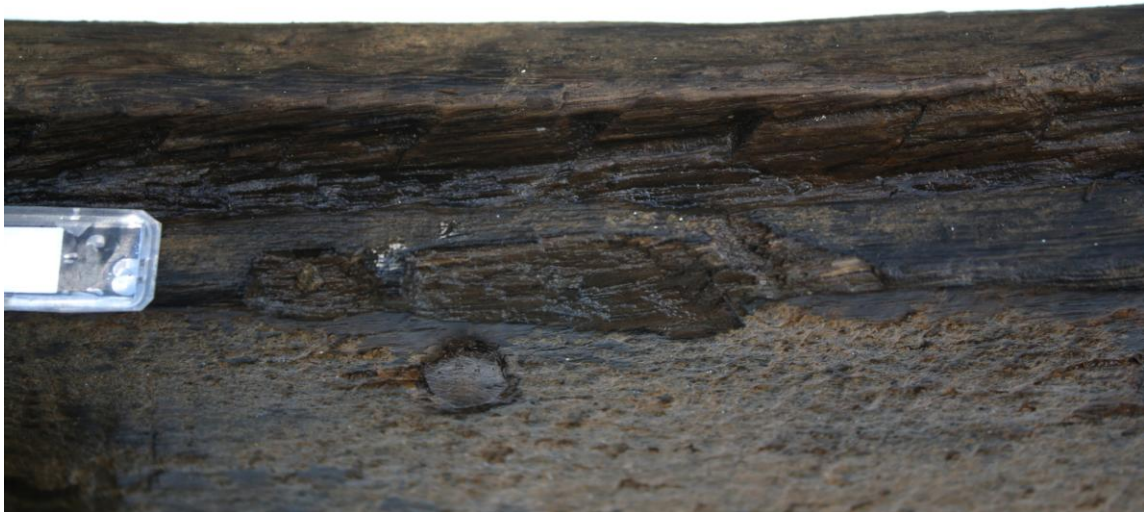
Figure 3.17: Tool marks from a chisel used in cutting a groove in the inner face of futtock F 37 for bulkhead planks.

with blade widths ranging from 2.0 to 4.3 cm were included among the carpentry tools on the seventh-century Yassiada shipwreck,²⁵⁶ while five chisels with minimum blade widths of 0.8-1.7 cm were found on the Serçe Limanı ship.²⁵⁷ Based on the widths of chisel marks left in the wood, the chisels used during the construction of YK 14 probably had blades at least 1.2-3 cm wide, similar to the blade widths of other Roman and Byzantine examples. Some of the clearest chisel marks on a frame, those in the groove cut into the inner face of F 37 for a bulkhead, are approximately 1.2 cm wide (Figure 3.17).

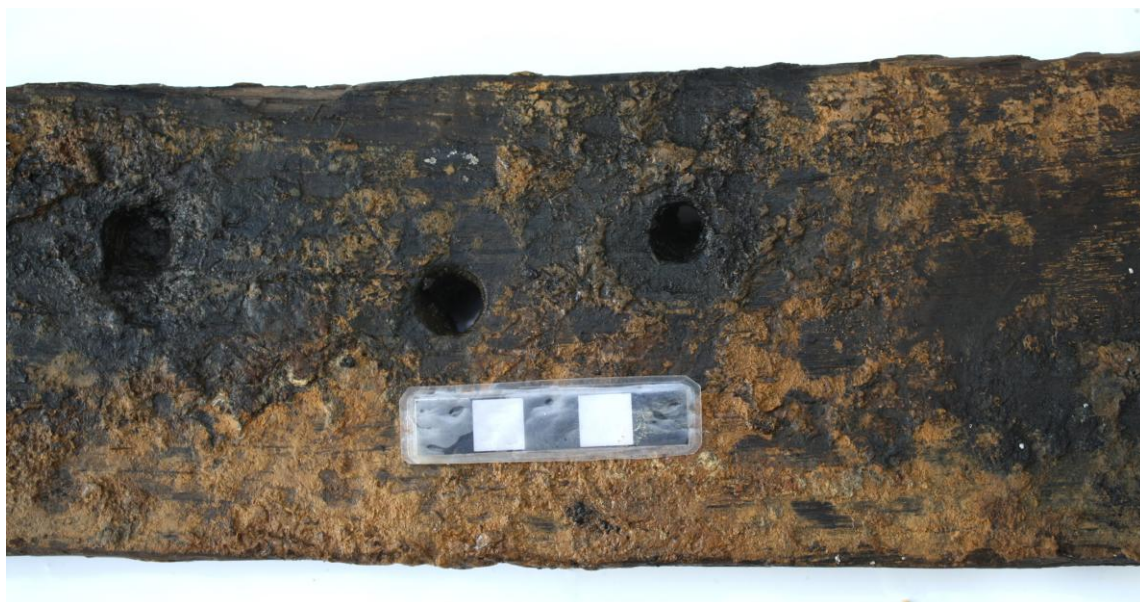
Figure 3.18: Drilled pilot holes for nails in the garboard strake near the aft end of SS 1-1/1A-5. Note the faint nail-head impression in the pitch around the drilled hole to the right.

Significant numbers of drilled holes served as pilot holes for nails (**Figure 3.18**). These would have been made to avoid splitting of the wood, which could cause leaks and weaken the connection between timbers, as well as to keep the nail following its intended path rather than the wood grain.²⁶¹ Pilot holes for nails can be of a smaller diameter than that of the nail itself, since the nail's holding strength derives from friction between the nail shaft and wood. One consequence of this is that some pilot holes may no longer be evident, having been obliterated when the nails were driven. Some of the smaller drill bits found on the Serçe Limanı wreck, with diameters of 0.7-0.8 cm, could

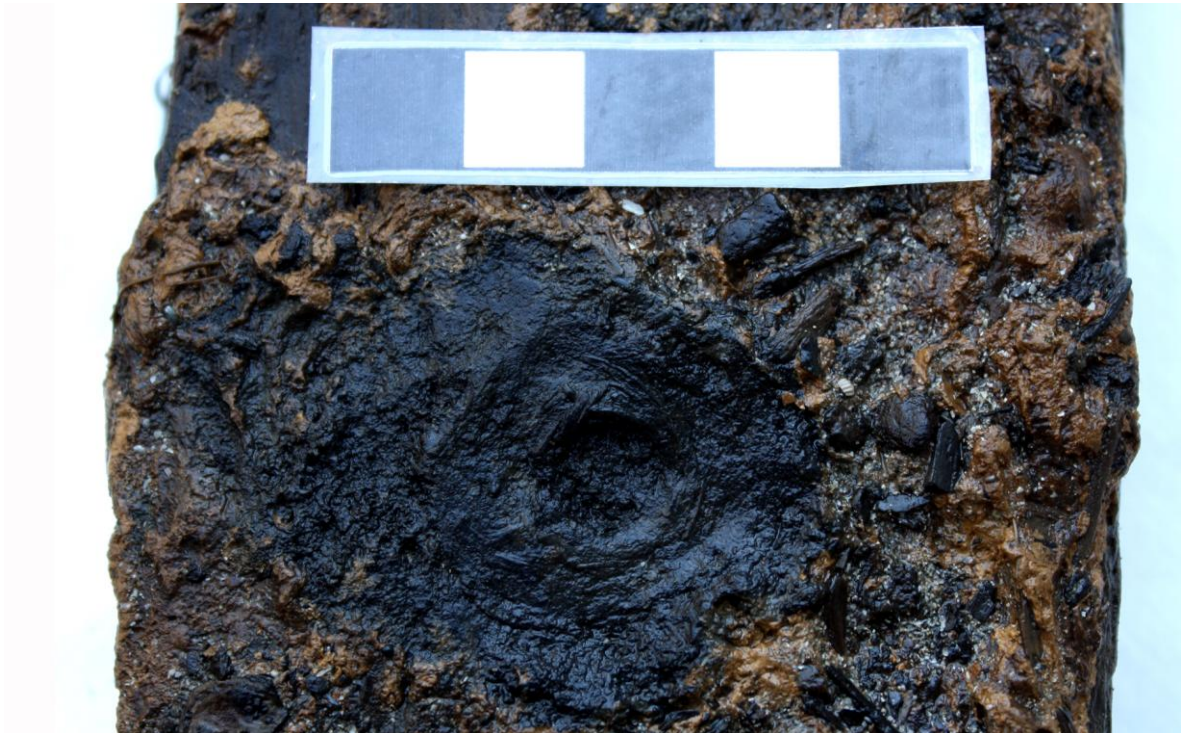
Figure 3.19: The outer face of plank SS 6-2/1-1A at the location of floor FL 25, where a nail head impression in pitch was preserved. Note the caulking fibers preserved in the concretion that were originally wound around the base of the nail shaft under the head. This nail was probably used as a repair nail.

Caulking fibers, apparently of grass, were found in many of the nail holes in the planking; the fibers had been wrapped around the nail shafts just below the head in an attempt to waterproof the fastener hole. This was a particularly common feature with nails driven into clearly distinguishable pilot holes (**Figure 3.19**). Thirty-two examples of this feature were noted in nail holes and nail concretions, with 16 occurring on certain or probable repair fasteners. It is unclear why they are so frequent on repair pieces, but it is likely related to better preservation of the waterproofing materials on many of the repair pieces; many of which can be assumed to have been exposed in the hull for significantly less time than the original timbers. Deep pilot holes were also routinely used for nails fastening repair components.²⁸⁷ This waterproofing method was observed in the hulls of several other shipwrecks from Yenikapı, and similar methods were used on other shipwrecks and in documented shipbuilding practices from later periods.²⁸⁸

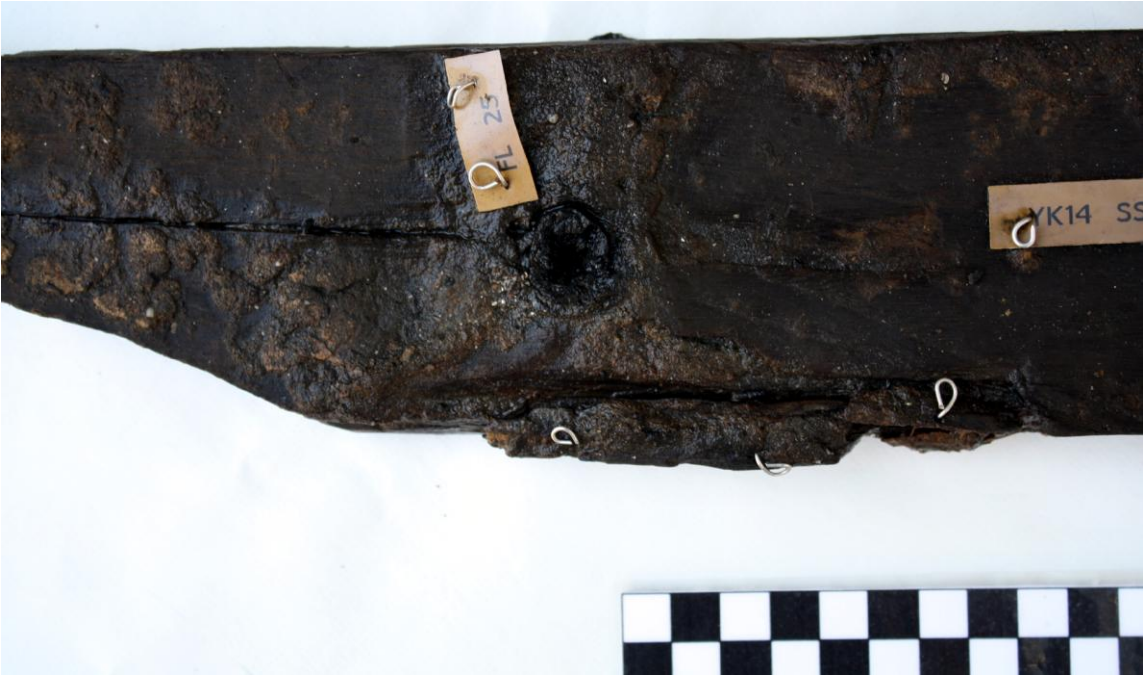
Figure 3.20: Evidence for repairs on SS 6-2.1-1A under FL 25, a strake at the turn of the bilge on the port side. Pitch was applied under the frame and in a rotten area along the keel edge of the plank, and a nail was driven through the treenail fastening the plank to FL 25. Two repair planks are also located in the immediate vicinity of this original plank.

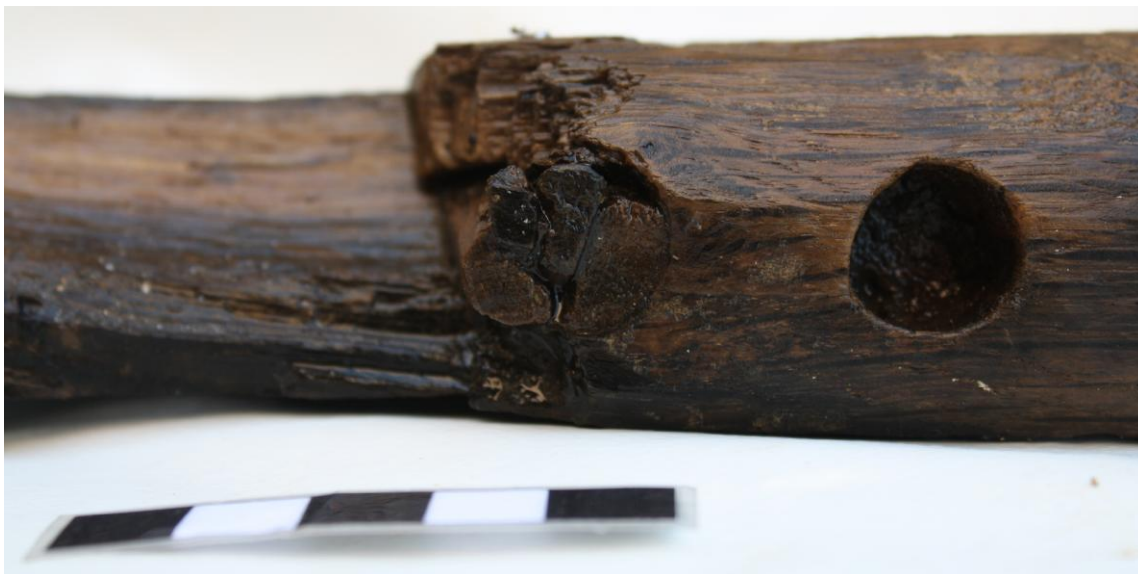
Figure 3.21: A wedged treenail used to fasten FL 25 to the wale (PS 13). The occurrence of wedged or spiked treenails is very unusual in YK 14's hull; their use seems to be restricted to the area of the waterline or above.

would have been significantly longer; the excess length was cut off after they were driven home tightly.³⁰² White deposits were observed on the exterior surfaces of some treenails after extraction from their holes; one analyzed sample of this material was identified as containing degraded pine pitch (see Chapter VI). This material could have leaked into the treenail holes, but it is also possible that the treenails were lubricated with pitch before driving in place, a practice mentioned by Plutarch and also known from later European shipbuilding practice.³⁰³ Treenails were polygonal in cross section and were originally shaped with an adze, but in many cases their edges became rounded by being forced into holes of the same or slightly smaller diameter.³⁰⁴ Very few of the treenails on YK 14 were wedged or pegged, a feature that appears to be confined to treenails at or above the ship's waterline; only five examples were found during the cataloging of the timbers. All but one example are from UM frame timbers that probably originate from futtocks or top timbers in the upper part of the hull or the upper ends of the 'long arms' of floor timbers (**Figure 3.21**).³⁰⁵

³⁰⁵ Pegged or wedged treenails were found only on a few frames, including TN 36 of FL 25, near the end of its upper 'long arm'; in TN 2 of FL 18, which fastened the floor to PS 13/Wale 1; in UM 3 (a probable end of the 'long arm' of a floor); and single treenails in UM 15 and UM 21, both futtocks or top timbers. These treenails were wedged on their inboard ends. It is possible that some treenail wedges were missed during the sampling of over 500 treenails in the planking for wood identification and the inability to examine the outer face ends of many of the treenails in the planking. The treenails were clearly driven from outside of the hull based on their tapering diameter. However, wedged or spiked treenails were not found among the significant number of treenails whose outboard ends were examined. Many of the treenails on the Serçe Limanı shipwreck were wedged with wooden wedges or iron nails (Bass et al. 2004, 98). The use of wedged or pegged treenails was also a common practice in post-medieval wooden

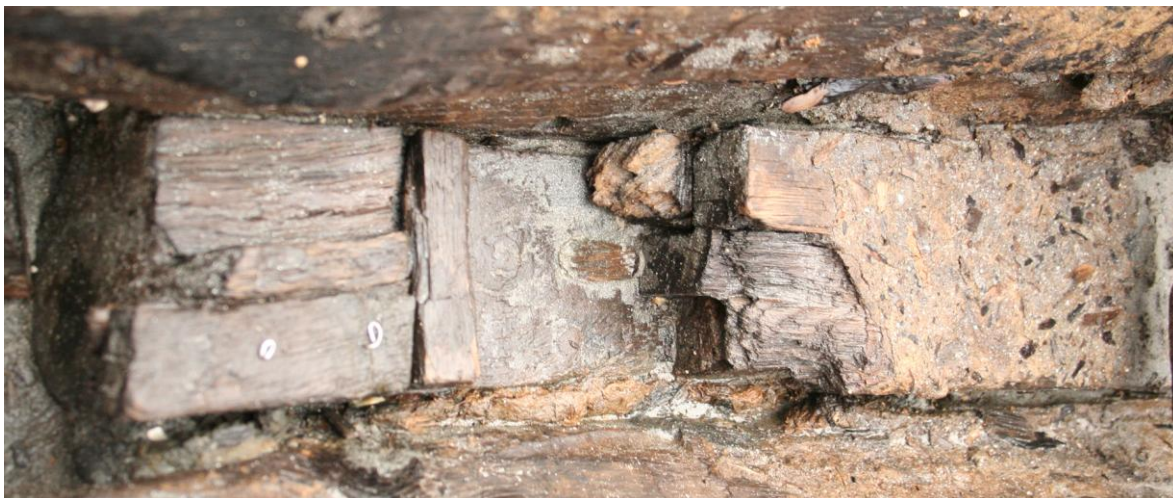
Figure 3.25: Sternpost fragment in Keel 1's aft scarf.

The ends of the ship, including the stem and stern, are missing, but part of the approximate curvature of the sternpost aft of Keel 1 was preserved by the intact hood ends of strakes 2 and 3 on both the port and starboard sides. Both the forward end of Keel 1 and the aft end of Keel 3 terminate with a keyed-hook scarf very similar to those connecting the Keel 1 and 2 and Keel 2 and 3 timbers. In the port-side mortise of Keel 1's aft scarf, a tenon from the original sternpost's hook-scarf end was preserved. The fragment measured 3.9 cm in length and has a roughly rectangular cross section (2.85 cm molded, 1.55 cm sided) (**Figure 3.25**). Similar to the other keel timbers, the sternpost was made from Turkey oak (*Q. cerris*). The hood ends for the garboard and those of the next few strakes join Keel 1 at a much steeper angle than on the opposite end of the hull, at the forward end of Keel 3. These features, as well as the greater width of the hull at Keel 3, indicate that Keel 1's location corresponds to the stern area of the ship.³⁰⁶

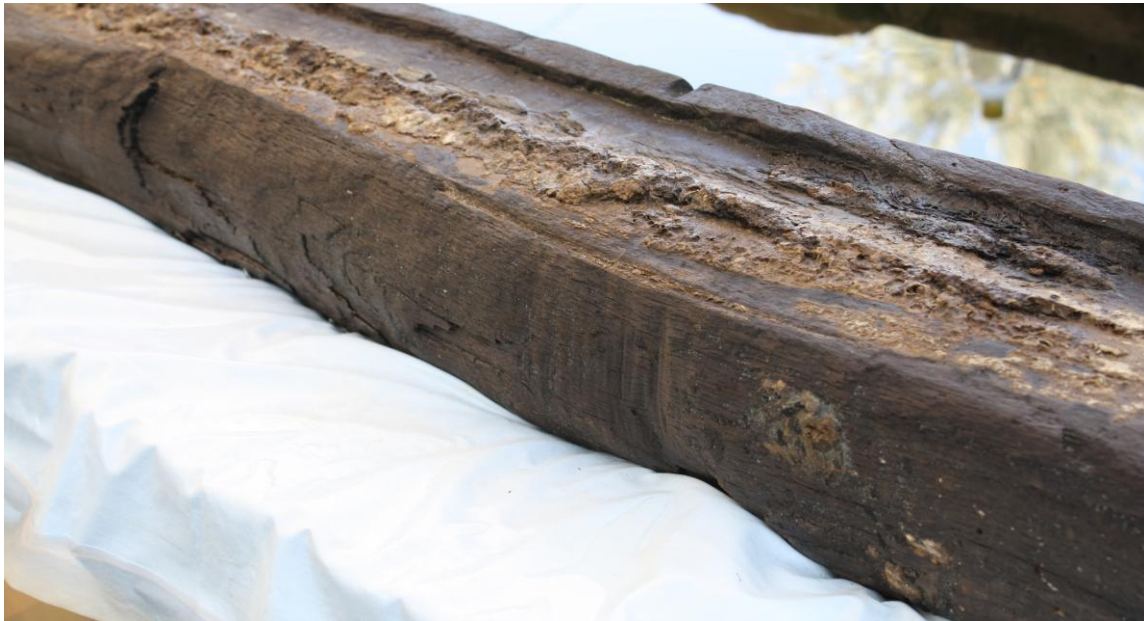
Figure 3.26: A section of the outer face of Keel 2, showing surface wear.

Most of the outer faces of the keel timbers are rounded and smooth, although some bevel cuts are still visible along the forward scarf end of Keel 3 (**Figure 3.26**). This smoothness seems to be due in large part to wear, but it also appears that in most areas of this face only the outer bark was removed from the keel timbers. No fastener holes or other evidence of a false keel were found on their outer faces. An area of more pronounced wear occurs in an approximately 40 cm-long section on the outer face of Keel 3 towards its aft end (FL 37-39 area) (**Figure 3.27-8**). Here, large portions of the original surface are missing; this damage is likely due to wear from beaching the vessel. Such damage was not observed on the other keel timbers.

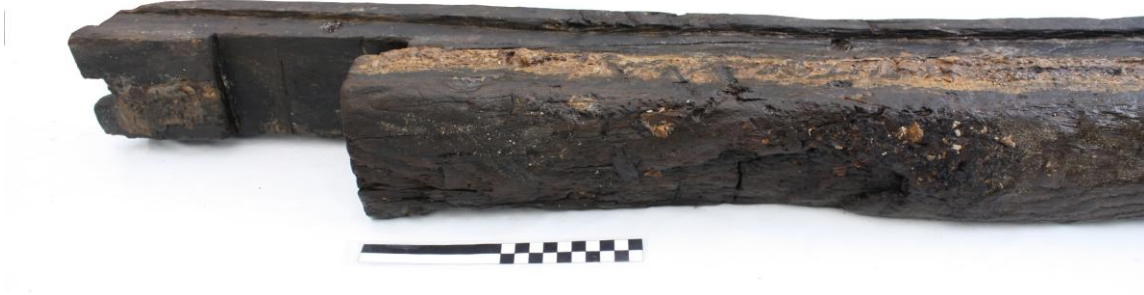
Figure 3.27: Worn area on the outer face of Keel 3 corresponding to the locations of floors FL 38-40.

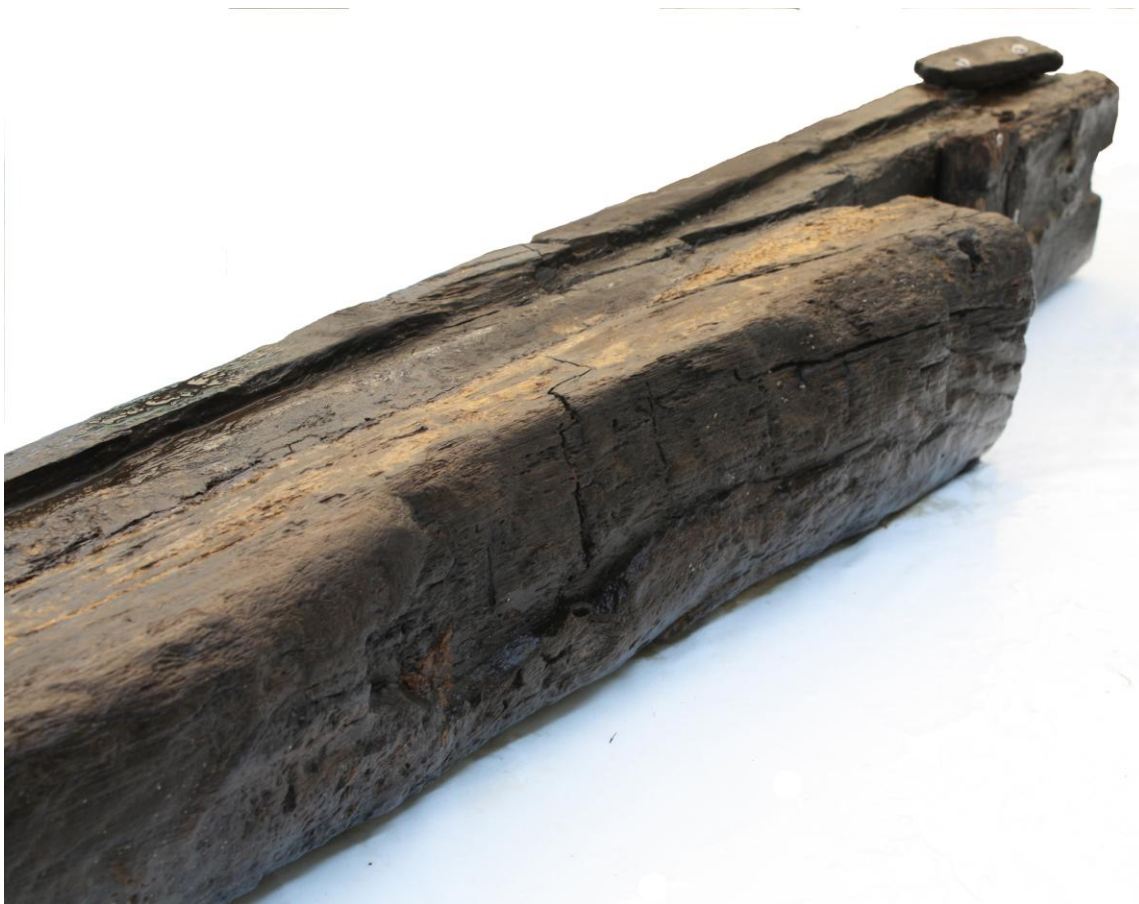
Figure 3.28: Detail of the worn area on the outer face of Keel 3, possibly caused by frequent beaching or grounding.

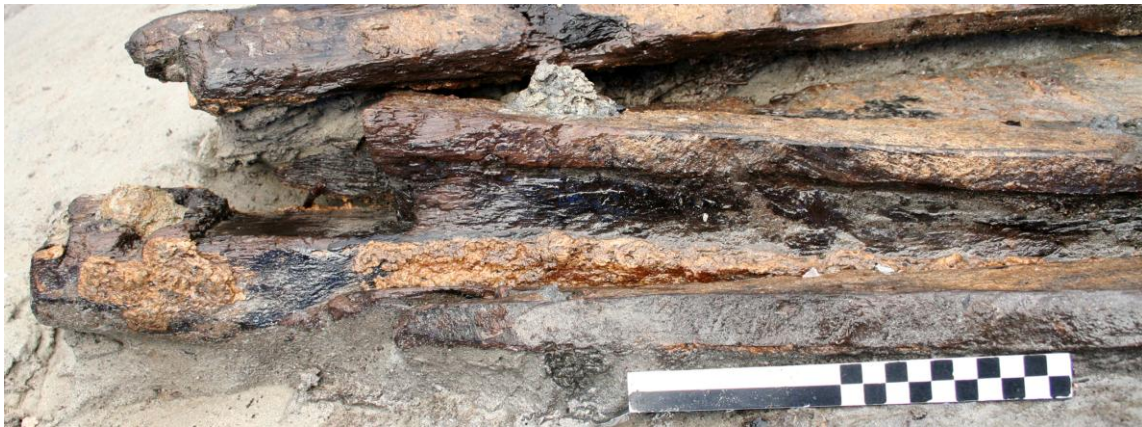
Figure 3.29: Forward scarf of Keel 3 during the excavation; note the wear around the scarf end and the rabbet.

this was the least exposed area of the timber; the garboards along the forward half of the Keel/SS 1 plank seam had been wrenched out of place during the ship's sinking. The worst surface preservation occurs on the port face of Keel 3, near the forward end scarf, which was fully exposed during the wrecking of the ship (**Figure 3.29**).

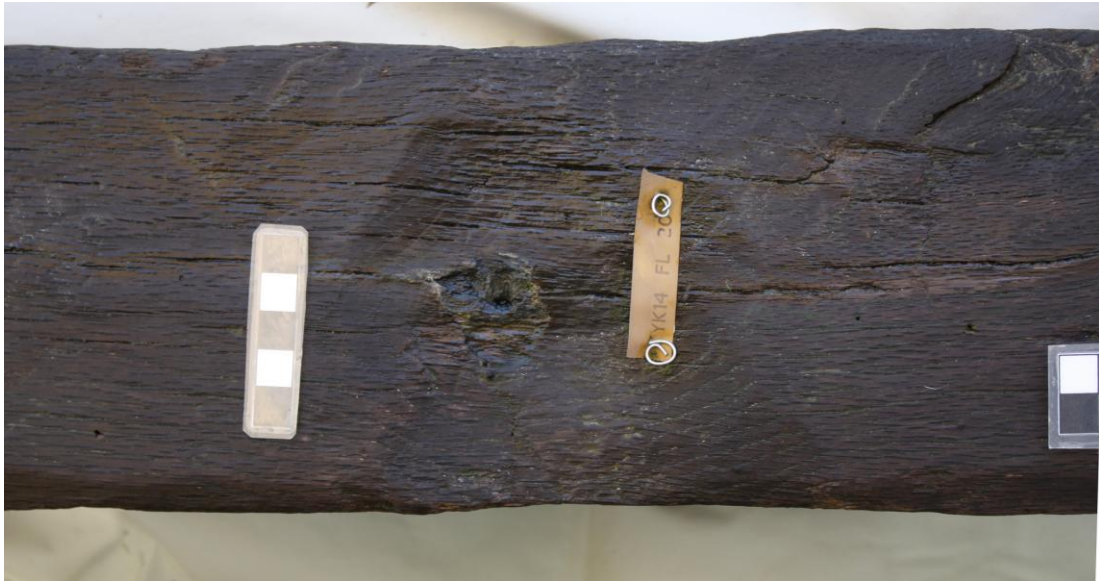
Figure 3.30: Adzed depression cut into the inner face of Keel 2 at the location of floor FL 20.

Frames FL 12, 14, and 20 were installed in the hull into adzed depressions on Keel 2's inner face, the depression at FL 20 being particularly deep (**Figure 3.30-1**). All three of these floor timbers were nailed to the keel. These depressions were probably cut after the lower planking was assembled and the floor timbers were being shaped to fit flush against the inner face of the keel timber; similar adzed depressions were found on some hull planks at frame locations as well. No score marks were found on the inner faces of the keel timbers to indicate frame locations or locations of edge fastener, with the

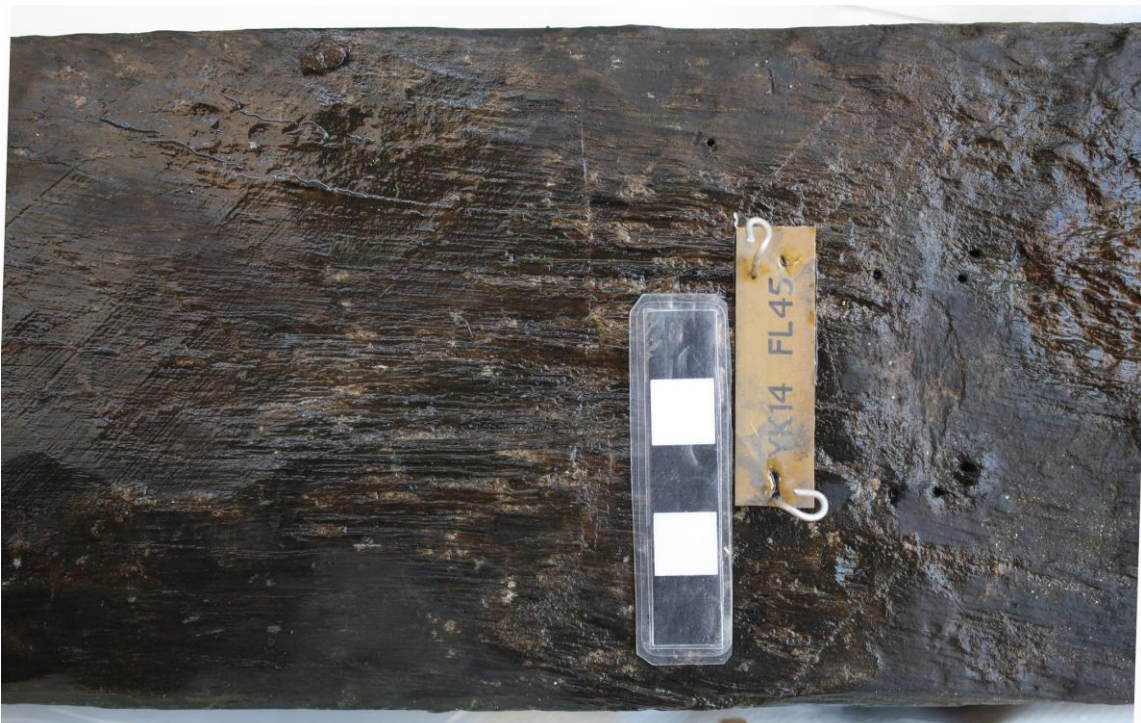
Figure 3.32: Possible score mark on the inner face of Keel 3, at the forward edge of the location of floor FL 45.

possible exception of a mark at the forward edge of FL 45 (**Figure 3.32**).³⁰⁸ Other marks may have been scored on the keel during construction but were later obliterated by adzing.

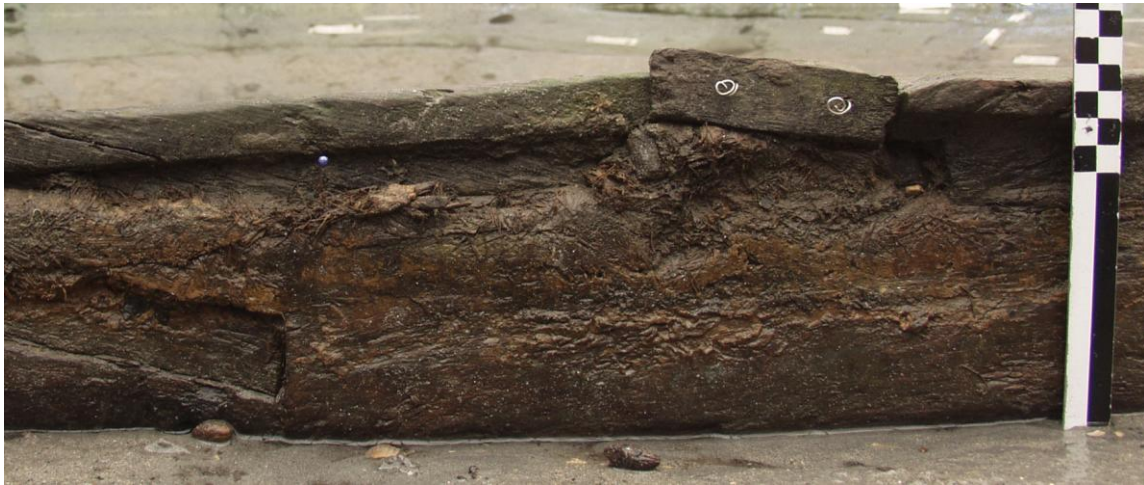
Figure 3.33: Heavy caulking discovered around the Keel 2/ Keel 3 keyed-hook scarf after removing the port garboard strake.

³⁰⁹ Caulking in other plank seams with no obvious signs of repairs tends to be 0.1-0.5 cm thick. A transverse crack in Keel 3, which begins at the scarf, may also have been a source of leakage and caulked with this material.

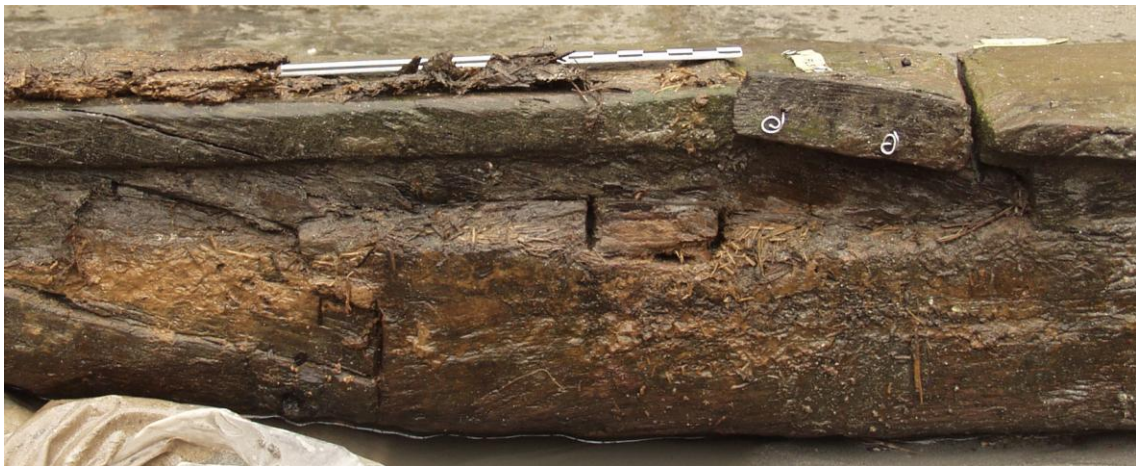
Figure 3.34: The port face of the Keel 2/Keel 3 hook scarf with most of the caulking removed. Note the scarf key.

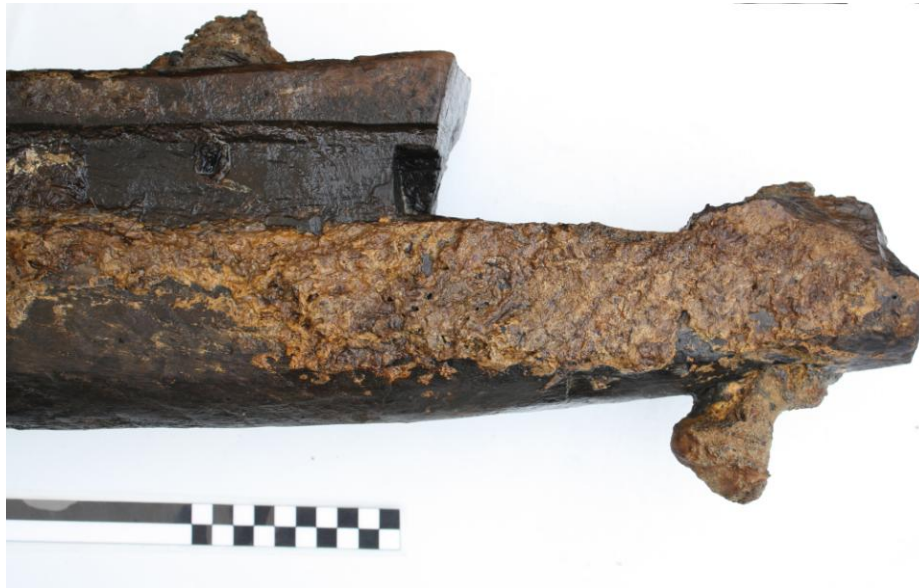
Figure 3.36: The forward scarf end of Keel 3. Note the concretion from the iron fastener driven in the forward end of the scarf.

The 21.6 cm-long forward scarf of Keel 3, although damaged, is similar to that on the opposite end of the timber; however, additional fasteners were used on this scarf (Figures 3.36-7).

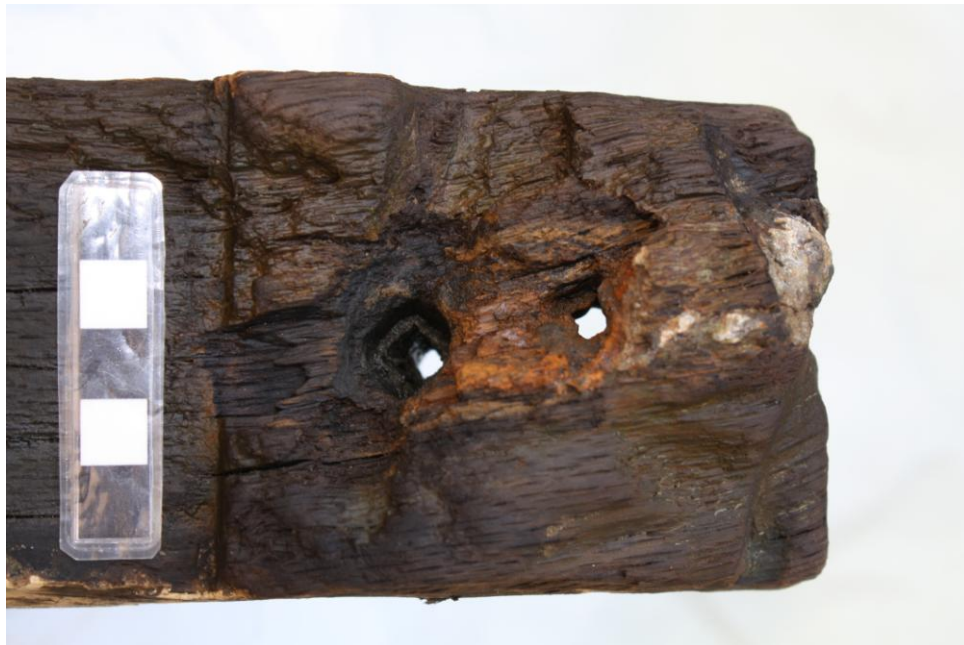
Figure 3.37: The fastener holes in Keel 3's forward scarf seen from above, after removing most of the iron concretion around the fastener holes.

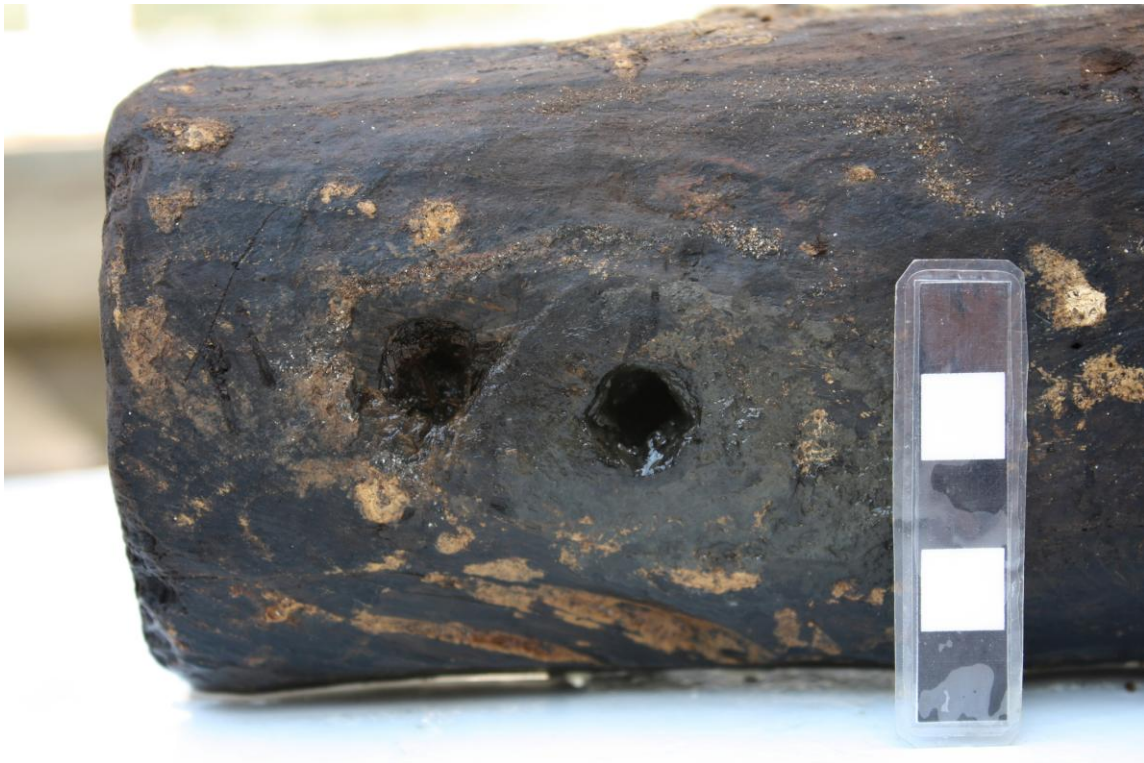
Figure 3.38: Pilot holes for fasteners in the outer face of Keel 3 at the timber's forward scarf. Note raised area around the head of a bolt or spike at right; the fastener's head seems to have protected the wood from wear. The hole on the left was filled with caulking on its outboard end, and contained a nail concretion on its inboard end, possibly from a floor timber.

Two pilot holes, 1.3-1.4 cm in diameter, were found containing iron nail or spike concretions, along with caulking material, in the forward of the two holes. The aft and larger hole contained an iron fastener shank with a maximum cross section of 1.3 x 1.2 cm, while the fastener shank in the forward hole is 0.5 cm squared on its outer face end, revealed after the caulking fibers were removed. The lengths of these nails were slightly longer than those of other nails used in the hull; they would have been at least 14.0 to 14.5 cm long if they only secured the scarf end, and 20 cm or longer if they were also driven through a floor timber or were clenched over a floor or endpost timber. No evidence of clenching or of a nail head were found on the outer face of the keel timber. However, the area around the aft fastener, which is approximately 3.5 cm in diameter, is less worn than the surrounding wood, indicating that it was covered by the head of an iron fastener, perhaps a bolt head based on the large diameter (**Figure 3.38**).

A concave depression, approximately 3.0 cm in diameter and 0.5-1.0 cm deep, was found in the concretion when it was removed, but it was unclear whether it was a poorly-preserved mold of the fastener's head or, more likely, a bleed from the iron concretion. The aft fastener was likely a large clenched nail or bolt used to fasten the scarf. The forward fastener's function is less clear. The diameter of the nail shank is accessible only on the interior end of the scarf, while the outboard end of the pilot hole was packed with caulking. Its use as a fastening a floor timber is possible, in which case it represents frame floor or futtock 52; the fastener hole is aligned with a drilled hole in plank PS 6-3 as well. Other possibilities include an abandoned fastener hole or broken nail, a

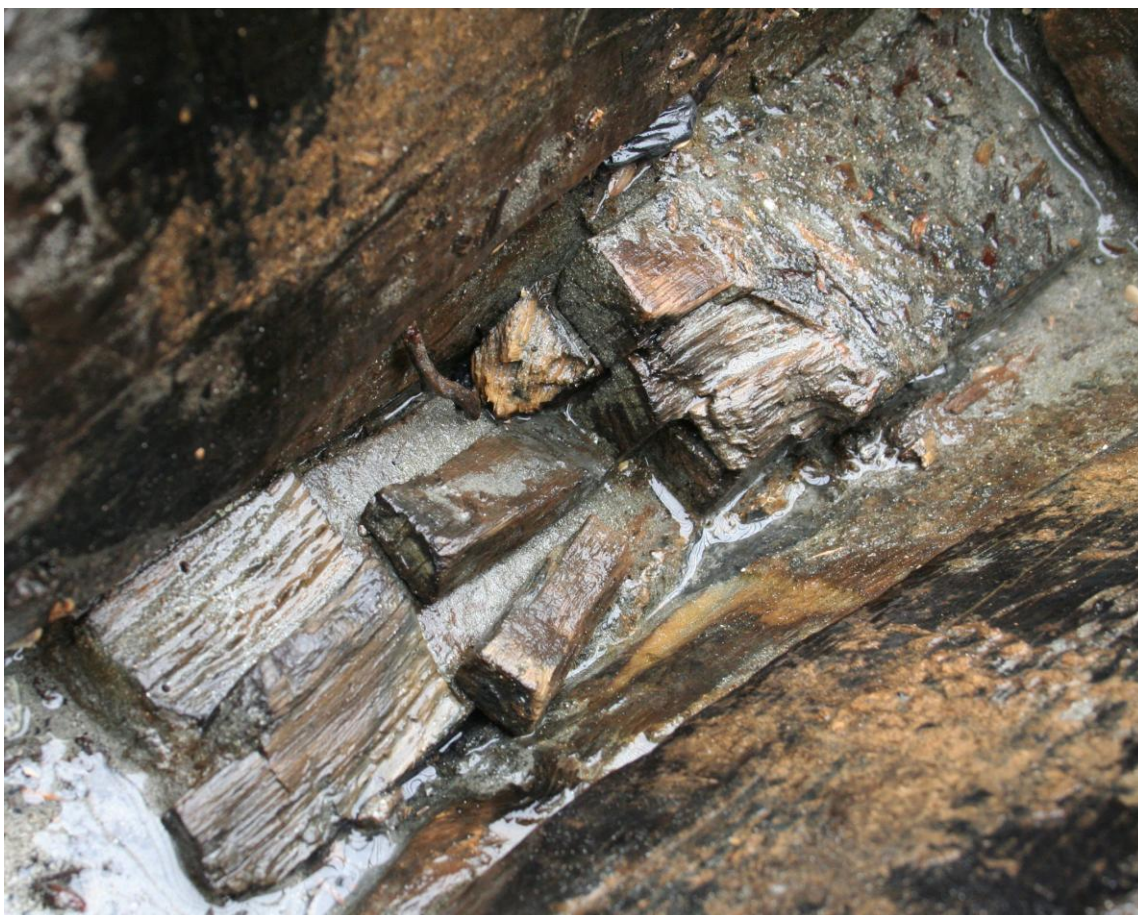
Figure 3.39: The aft scarf of Keel 1 after excavation. The scarf key and a piece of the scarf were found loose.

The 21.1 cm-long Keel 1/sternpost scarf at the aft end of Keel 1 is similar to the Keel 3 scarf end in the bow. A rectangular piece of wood was found in the bilge just behind the scarf (**Figure 3.39-40**). Because its length is the same as the sided dimension of the keel at the after end of the hull, this wood piece is almost certainly the scarf key for the joint. No other fasteners were used to secure the scarf end. A 0.3-0.4 cm-thick caulking deposit found in the port mortise of the forward end of the scarf, indicated that the scarf tenon from the missing sternpost timber was not a tight fit on this side for the mortise in Keel 1.

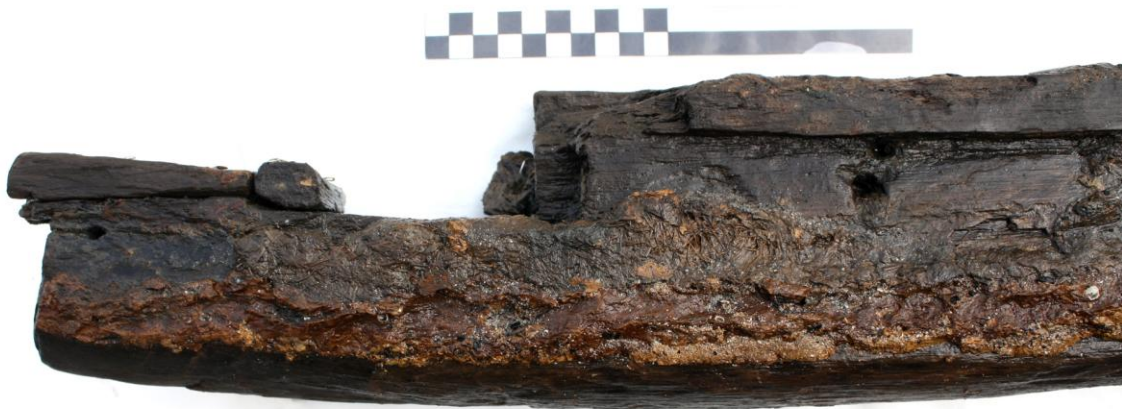
Figure 3.40: The aft scarf of Keel 1, with loose wood fragments and scarf key secured in their original locations.

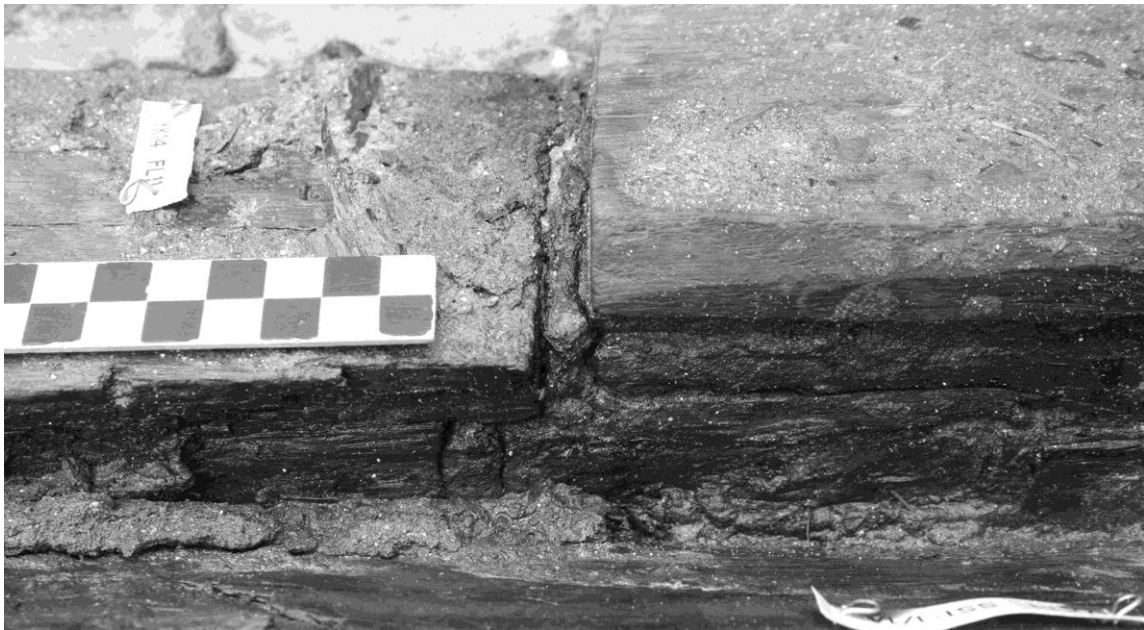
Figure 3.41: Pitch in the gap between the inner faces of Keel 1 and 2.
